Icon Reserve Pilot Chute Failed to Clear Side Flaps, Ser #IN-I5-12509, DOM Sep 2008

**Regarding test-report for pilotchute hesitation on Icon I5 SN#12509**

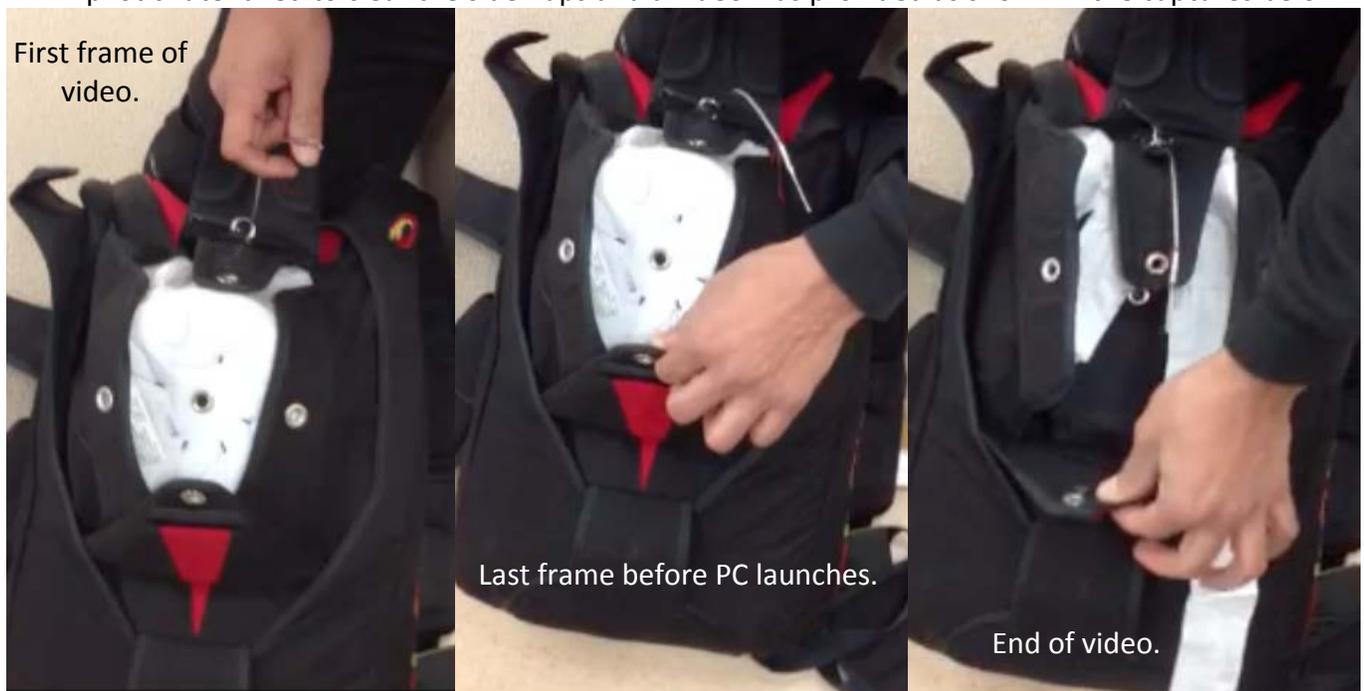
19 November 2012 it was reported that when the pin was pulled for routine repack, the reserve pilot chute failed to clear the side flaps and a video was provided as shown in the captures below.

It was noted from the provided video that the rig was not being worn and the pin was not pulled by its handle. The video shows that it was sitting on the ground and appears to have been pulled by the cable close to the pin, this would mean that this rigger's hand had to have contacted the #5 flap once the pin was clear of the loop interfering with its normal activation.

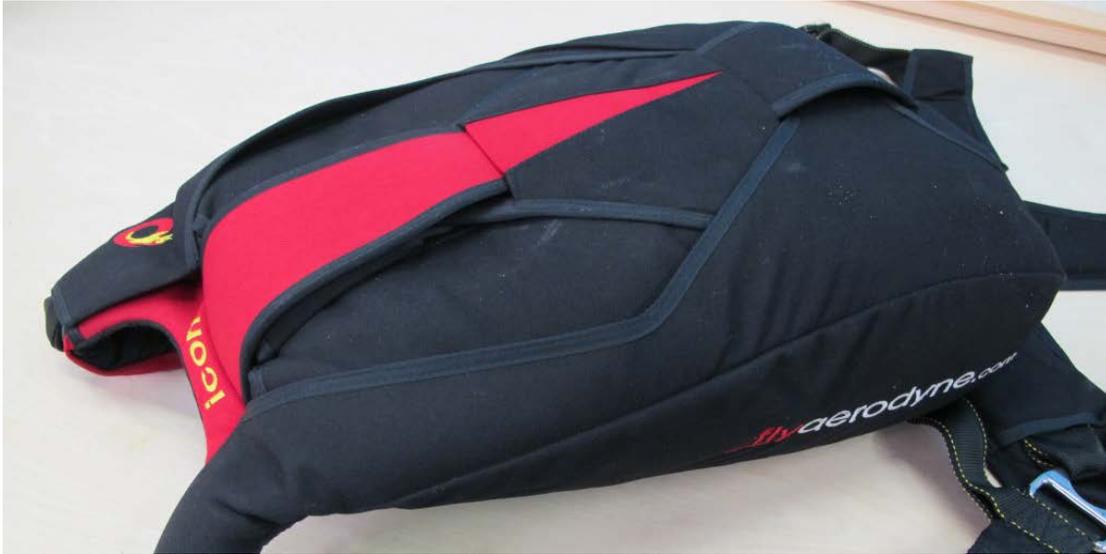
The rig arrived 29 November 2012 with the reserve closed as shown below and the first observation was that the loop was on the excessively long side and the reserve PC was not at full compression.

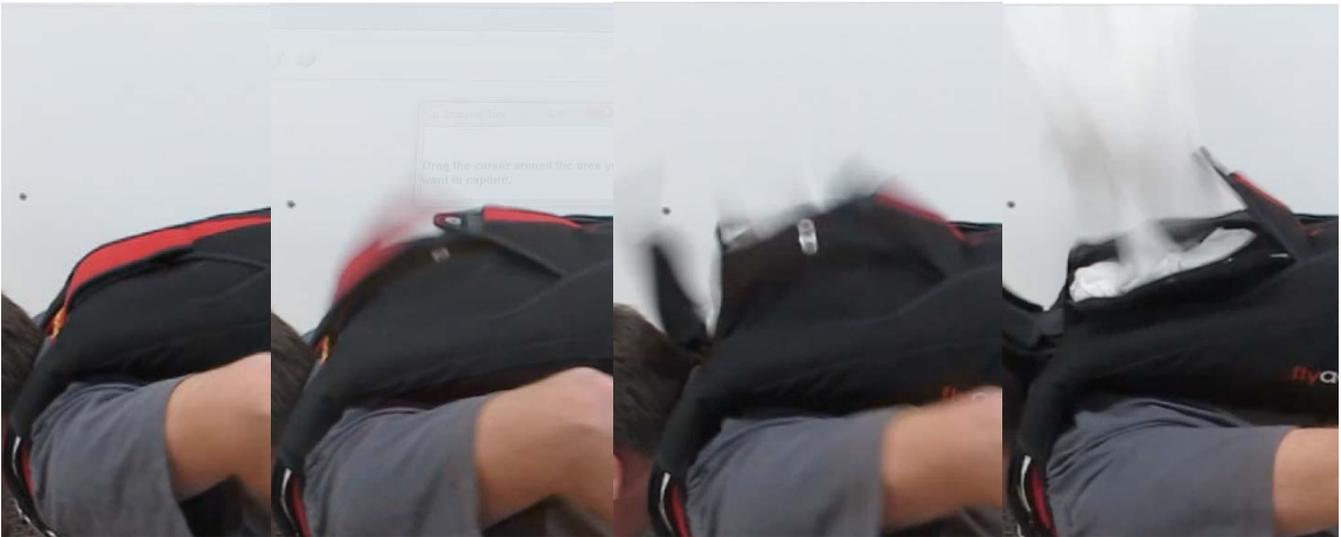
The rig was then test pulled exactly as it arrived. A good launch with no hesitation was observed. See captured video below. Video provided upon request.

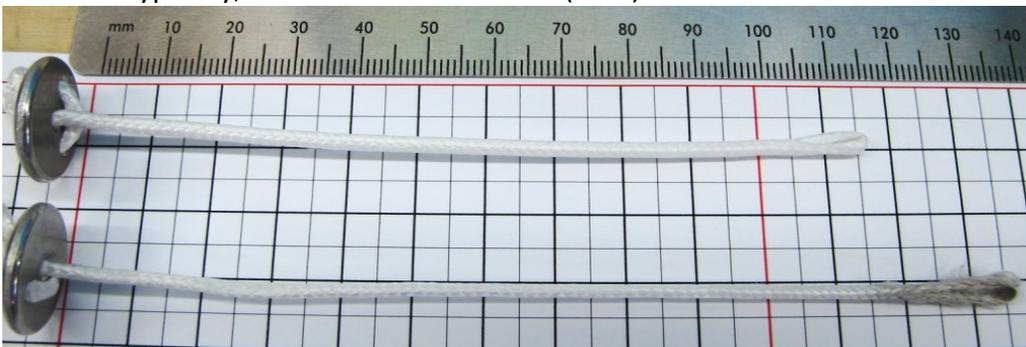
← Actual loop taken from I5 #IN-I5-12509.

After opening, the loop measured to be 137mm (5 3/8"), this is common length used here on tandem reserves. Typically, we would use a 115mm (4 1/2") with this combination.

Riggers in the field should note that when opening a reserve for its scheduled repack that all manufacturers advise that it should be worn on the shoulders and actuation initiated by ripcord handle.
