SERVICE BULLETIN SB271107

ICON CONTAINER GROMMET INSPECTION Issue Date : November 27, 2007

Identification: All ICON Harness/Container.
Part Number: P120
Manufactured After and Including 01 September 2007

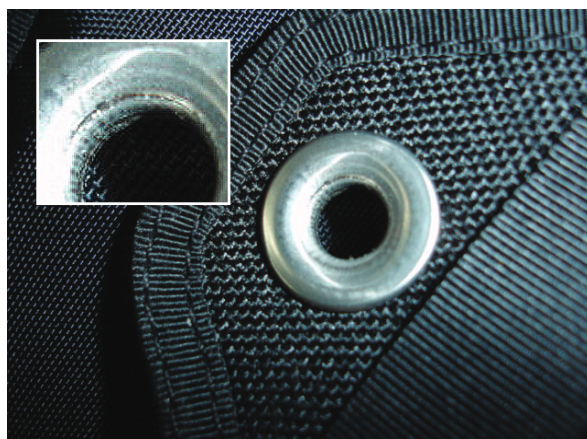
The Damage can be seen on the inside of the Grommet where the Closing Tool has scratched the Inside Surface of the Grommet. The seating of the Grommet needs to be inspected to ensure correct and flush seating of the Grommet.

1. Damaged Grommet
see damage on inner ring of grommet

This could well be an isolated incident, but as a matter of precaution Aerodyne is recommending all Grommets on the ICONs listed in the Identification paragraph above be Inspected.

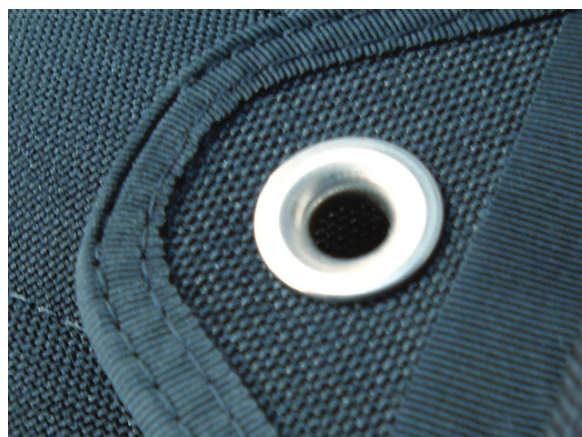
1. Undamaged Grommet
