SERVICE BULLETIN SB271107

ICON CONTAINER GROMMET INSPECTION Issue Date : November 27, 2007

Identification: All ICON Harness/Container.
Part Number: P120
Manufactured After and Including 01 September 2007

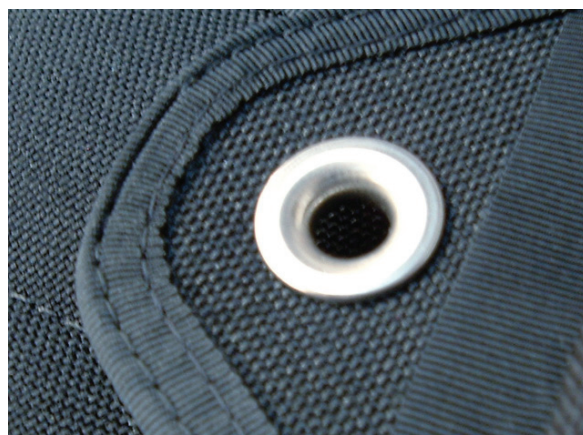
1. Undamaged Grommet
