# Service Bulletin

Subject: Service Bulletin for Icon S7, S8 and S9 Student rigs

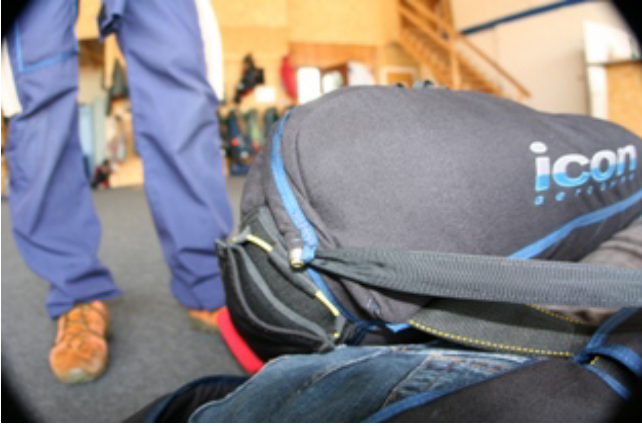
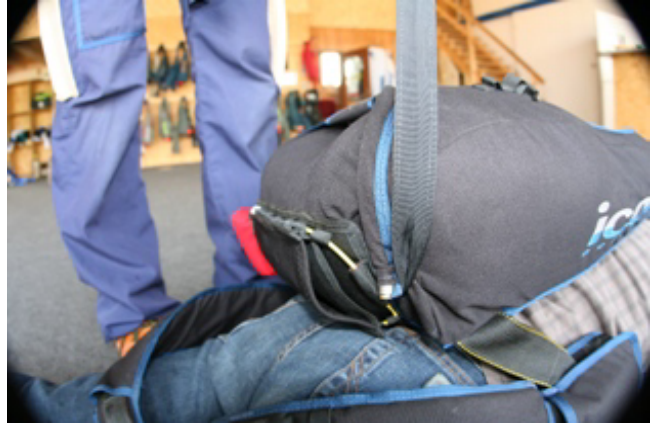
The following pictures demonstrate the problem.

On deployment, it is possible for the bridle to catch on the housing.
