# Manufacturer Product Service Bulletin

## Number CW03-01

**Subject:** Capewell Supplied Pins and Ripcords

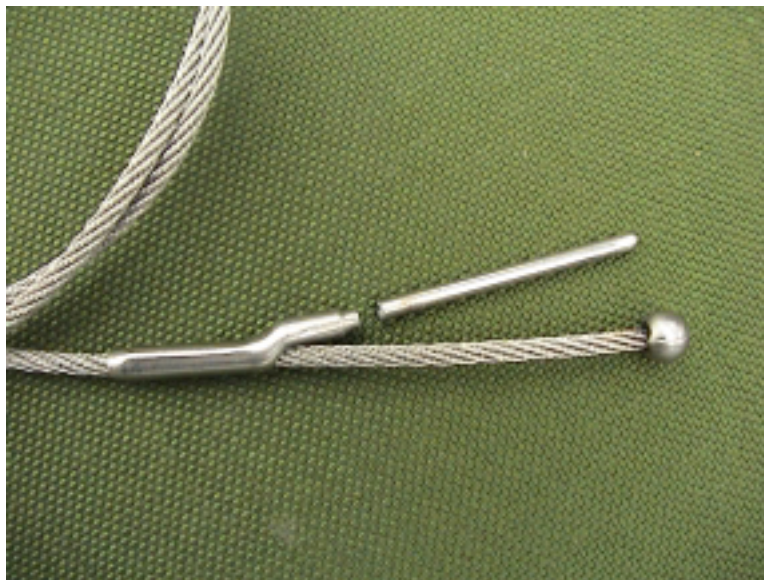
Broken Ripcord Pin

Capewell Components LLC has received (3) reports from (3) customers of (4) ripcord pins that broke. All (4) pins were reported to have broken under very low force. All (4) pins are reported to have broken on the blade section of the pin, approximately 1/8" (3 mm) from the shoulder of the pin. A broken pin is pictured below.

Two of these ripcord pins that broke were supplied by Capewell as a completed ripcord assembly. Two of the ripcord pins that broke were supplied as pins to Capewell customers who then assembled the full ripcord. The (4) ripcord pins that broke were delivered to Capewell customers in the first half of 2002.

Capewell has an on-going investigation to determine root cause. No root cause(s) has been determined to date.

Affected Ripcord Pins are: MS70107 (angled), PS70107 (angled), 61C4304 (angled); 55A6480 (terminal)

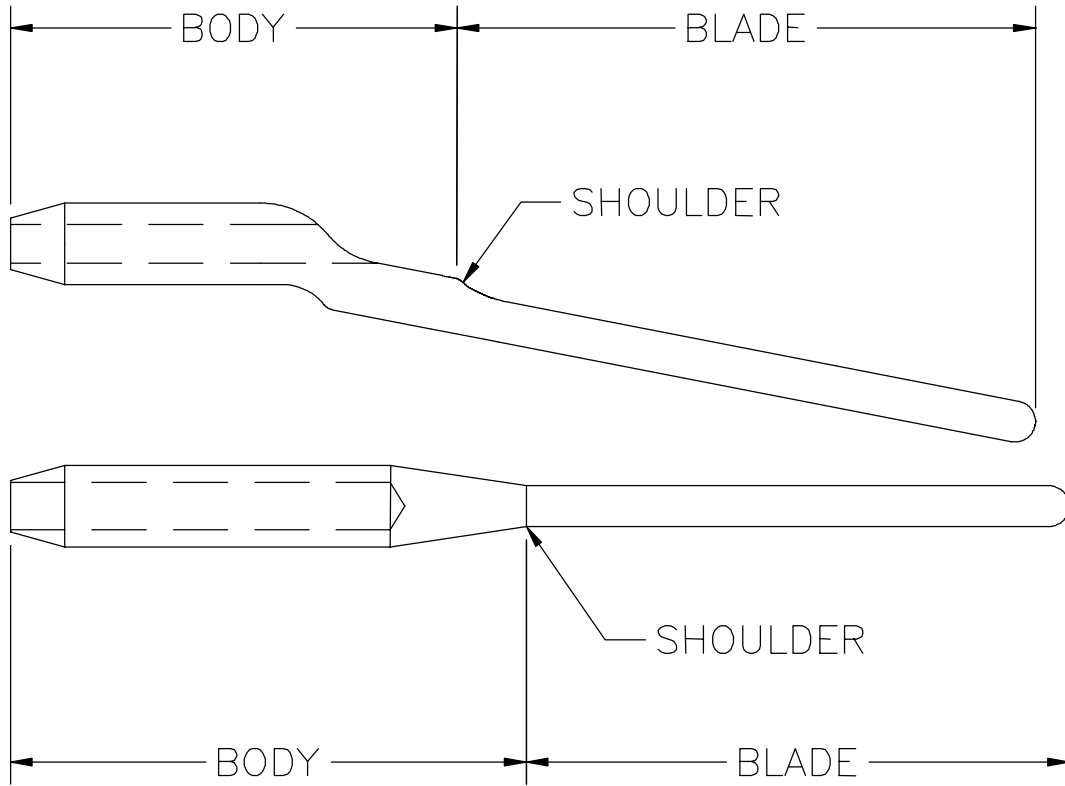
The figure below is provided for clarity to all procedural instructions.

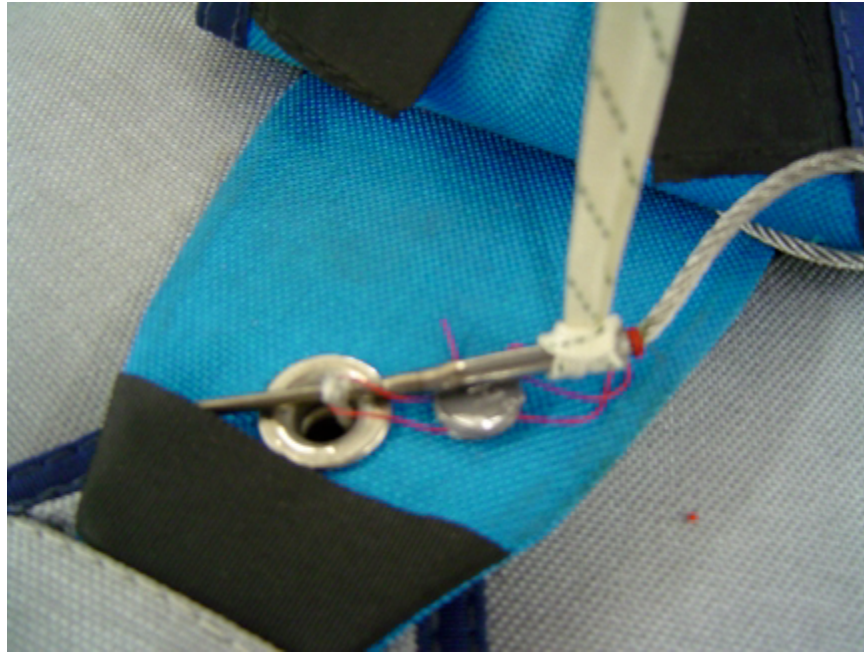
**FIGURE 1**

3. Take the suspension line and tie the two ends together with an overhand knot forming a loop.
4. Route the loop around the body of the pin to form a lark's head knot as close to the cable entrance end of the pin body as possible (Fig. 1).

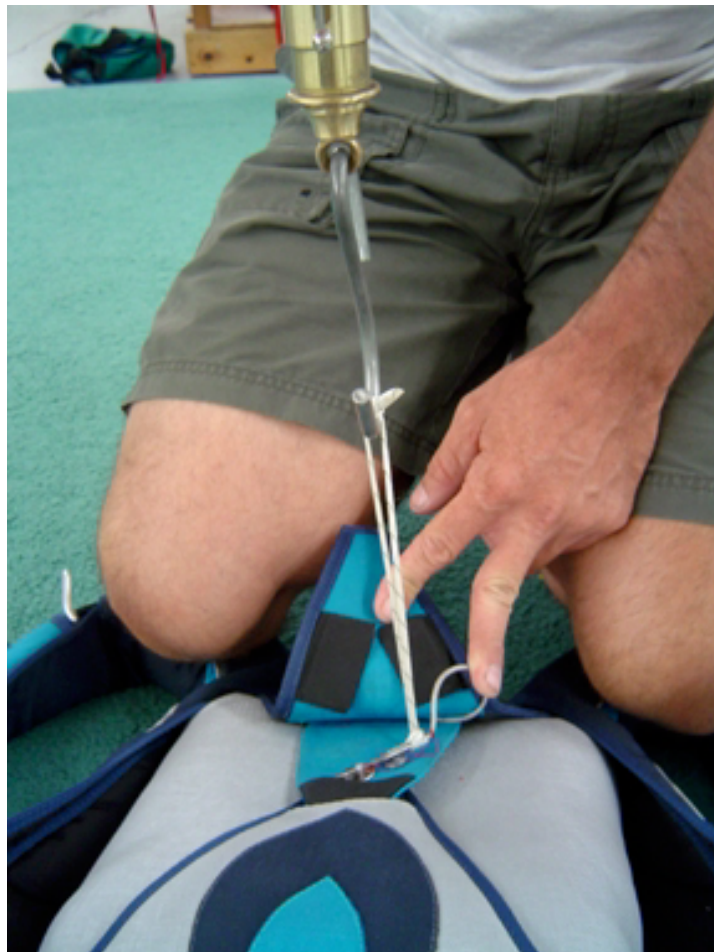
**FIGURE 2**

5. Secure the other end of the loop to the spring scale.
6. Apply a load of 15 lbs. (6.8kg) straight up and 90 degrees to the axis of the pin for a period of 3 seconds and then release the load (Fig. 2). Inspect the pin for any deformation or bend. If the pin is straight, continue with step 7 below. If the pin is not straight, as visible without magnification, remove the pin/ripcord from service immediately.

7. Mark the inspected side of the pin with the felt marker to avoid repeatedly testing the same side of the pin.
8. Rotate the pin one-quarter turn and test again as in step 6.

9. Repeat the procedure in step 6 until the pin has been tested in four positions and rotated one-quarter turn in the same direction prior to each test.

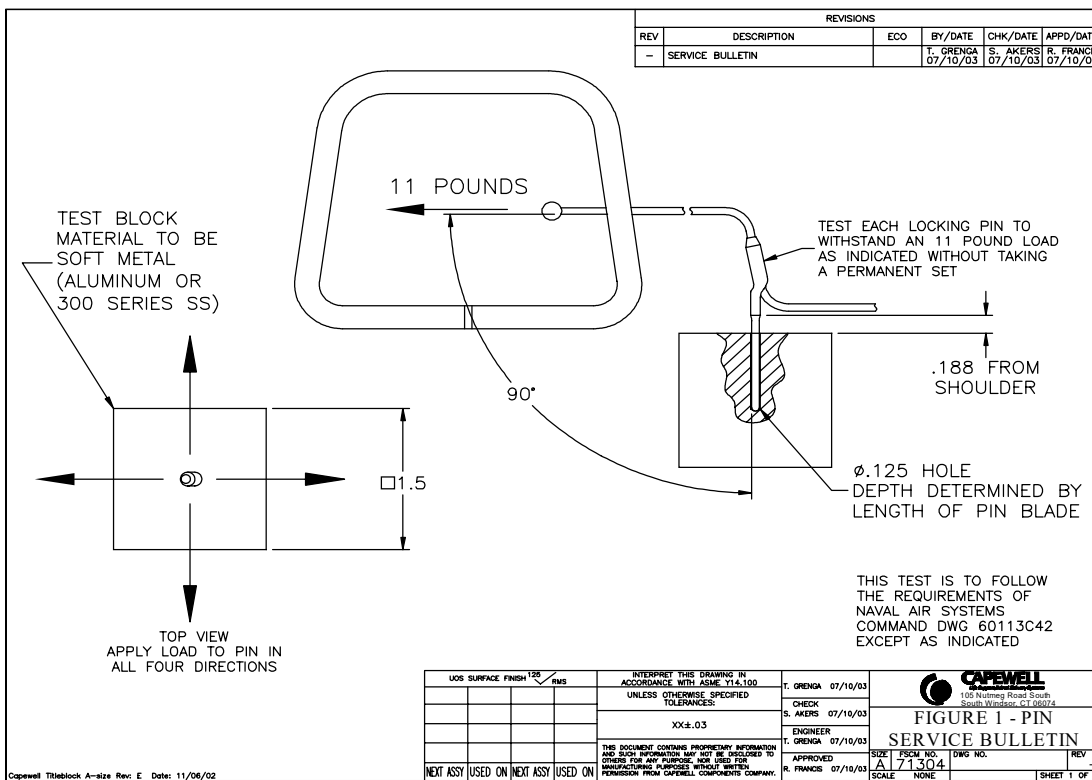
**FIGURE 3**  
All dimension in inches

1. Place pin in test block per Figure 3 (below). NOTE: The pin block hole may be VERTICAL or HORIZONTAL
2. Apply 11 lb. force 90 degrees perpendicular to the pin blade.

3. Remove pin from block and inspect:
  - For straightness: Pins in excess of .005 (.12 mm) deformation along the blade of the pin should be removed from service.

- For surface anomalies using 10x magnification. If any surface anomalies (dents, cracks, chips) exist, the pin should be removed from service.
4. Mark the inspected side of the pin with the felt marker to avoid repeatedly testing the same side of the pin

5. Repeat steps 1 through 3, each time rotating the pin 90 degrees in the same direction, until the pin has been tested in 4 directions.
6. Upon successful completion of test, ripcord handle will be marked with **CW03-01**.
